AIRCRAFT GROUND-FLOTATION INVESTIGATION PART V DATA REPORT ON TEST SECTION 4

W. BRABSTON and W. HILL, JR.
U. S. ARMY ENGINEER WATERWAYS EXPERIMENT STATION

TECHNICAL REPORT AFFDL-TR-66-43, PART V AUGUST 1966

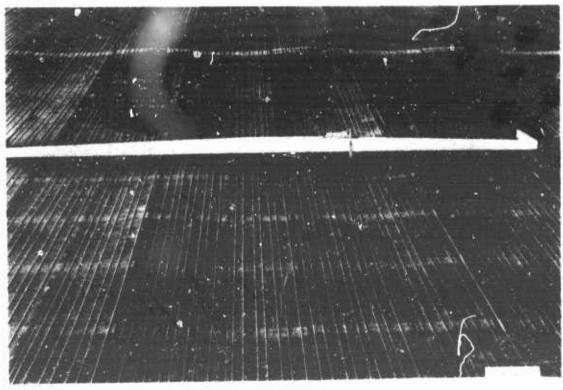
Fig 7. Lane 7, item 1. Longitudinal straightedge shows roughness at 300 coverages (failure)

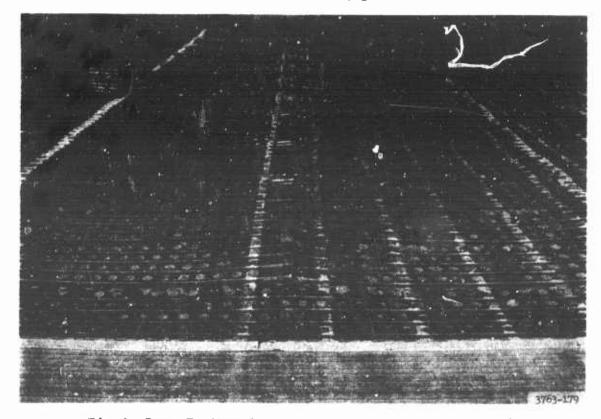
- Item 2. Fig 8 shows item 2 prior to traffic. The M8 mat surface did not have a large number of breaks at 200 coverages when the item was considered failed due to roughness (Figs 9 and 10). At coverage levels near the failure point, the panel ends at the mat joint near the center line began to project upward (Figs 9 and 10). The rated CBR of the item was 4.9.

Fig 9. Lane 7, item 2; general view at 200 coverages (failure)

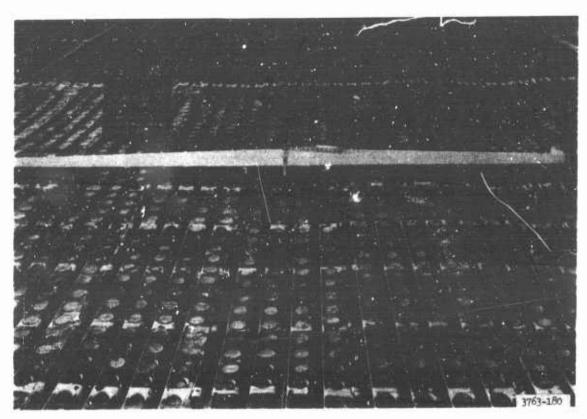
Fig 10. Lane 7, item 2. Longitudinal straightedge shows roughness along mat joint line at 200 coverages (failure)

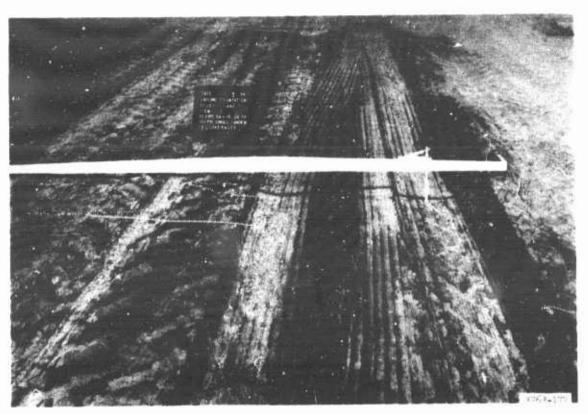
- Item 3. Item 3 prior to traffic is shown in **Fig 11**. The item was in serviceable condition at 80 coverages, but had greatly deteriorated when data measurements were again taken at 128 coverages (**Fig 12**). After studying data collected at 128 coverages, it was decided to antedate the time of failure to 100 coverages. Failure was due to excessive rutting. The rated CBR of the item was 9.3.

Fig 12. Lane 7, item 3. Transverse straightedge shows rutting at 128 coverages (28 postfailure coverages)

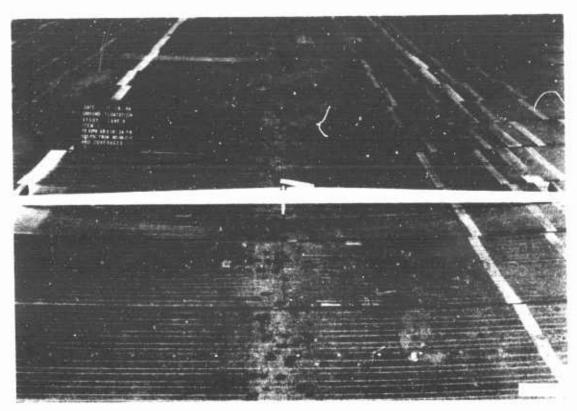
- Item 1 is shown prior to traffic in Fig 13 The item held up well under traffic and did not have an excessive number of mat breaks at any time. Traffic was applied to the 460-coverage level when the item was considered failed due to roughness (Fig 14). The rated CBR for the item was 2.4.
- Item 2. Fig 15 shows item 2 prior to traffic. On mat runs having the mat joint located near the lane center line, the panels deformed in a concave upward shape along their length causing the panel ends to extend upward at the joint. This condition contributed to transverse and diagonal roughness in the lane. No mat breaks occurred during testing. At 142 coverages the item was considered failed due to roughness (Figs 16 and 17). The rated CBR was 4.0.

Fig 14. Lane 8, item 1. Transverse straightedge shows roughness at 460 coverages (failure)

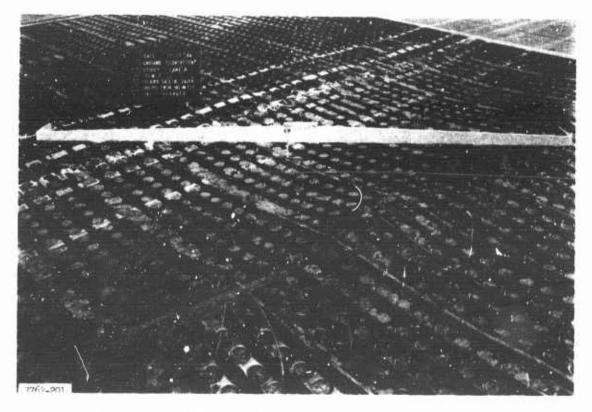
Fig 17. Lane 8, item 2. Diagonal straightedge shows roughness at 142 coverages (failure)

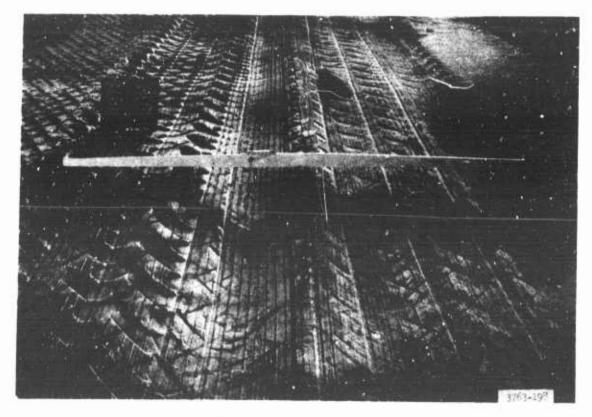
Item 3 prior to traffic is shown in Fig 18. The item remained in good condition through 20 coverages with rut depths averaging 1.56 in. Continued trafficking resulted in progressive rutting and failure of the item at 62 coverages (Fig 19). The rated CBR for the item was 9.8.

- a. Roughness. Differential deformations and rut depths at 20 and 62 coverages are shown in table 1. At failure the average rut depth was 3.72 in.
- b. Deformation. Average permanent soil deformations at 20 and 62 coverages are plotted in Fig 23 and 24 for cross section and profile, respectively. The cross-section plot reflects a ridge down the lane center line, as shown in Fig 19.

Fig 19. Lane 8, item 3. Transverse straightedge shows rutting at 62 coverages (failure)
